VEHICLE INSPECTION REPORT

Date of Inspection : **13/10/2026**

BMW BM320D 320D

2014 | 152727 KM | DIESEL

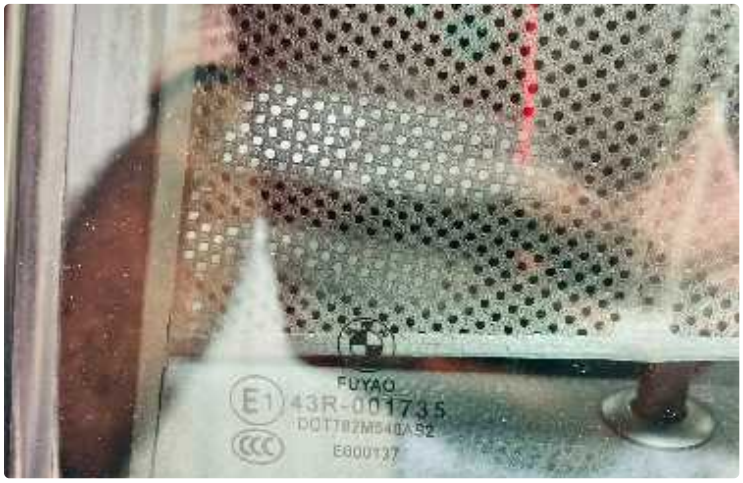
FUYAO
43R-001735
E000137

FUYAO
43R-001735
DOT782M540AS2
E000137

PILKINGTON
43R-001586
E000199
OCP N° 0003
19

A full periodic service is recommended, including engine oil, brake fluid, and filter replacements.
